## UTILITY LOCATING & GPR UTILITY SCANNING

PROJECT SITE:  
NEWARK, CA

**Reference:** #123456789

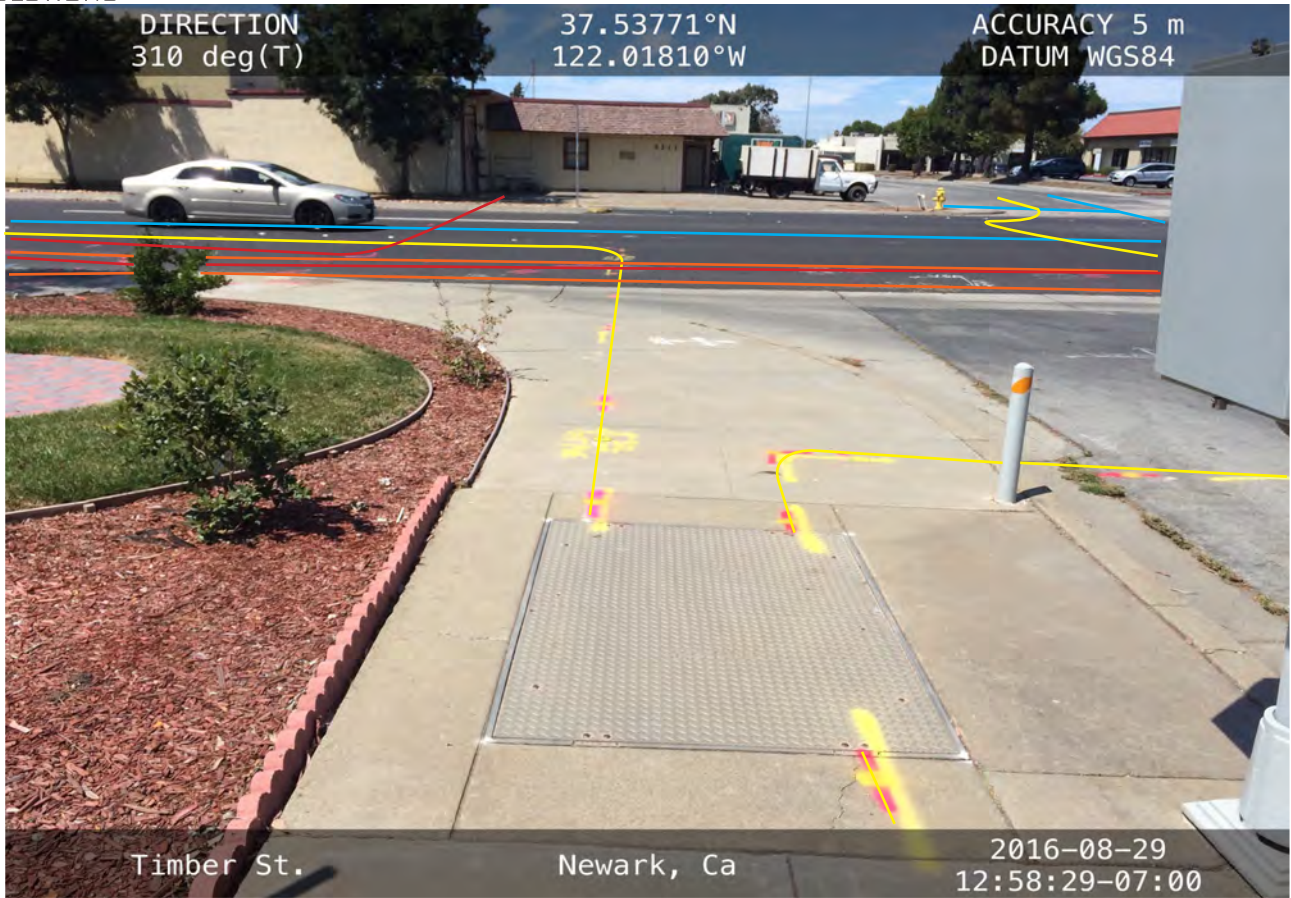
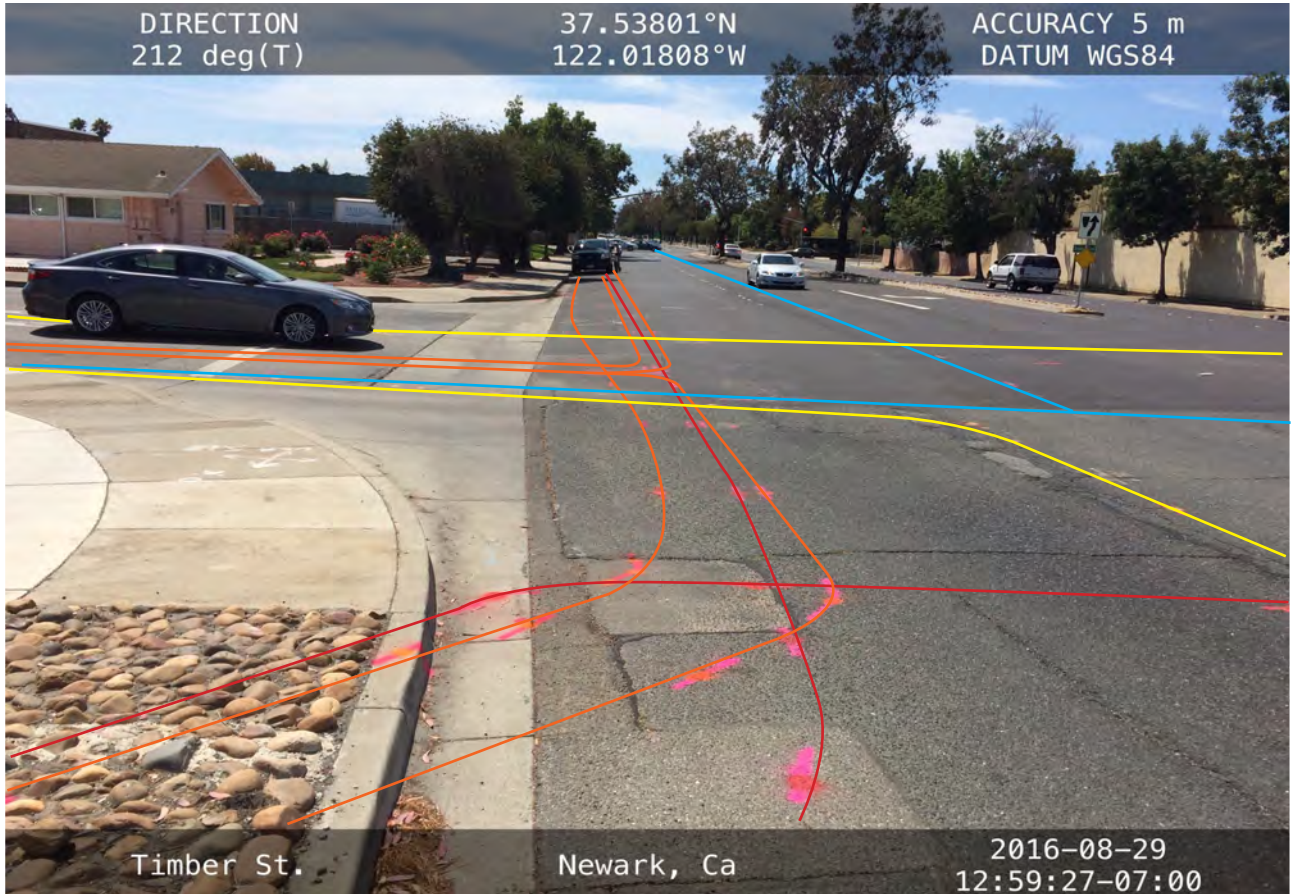
Designated area was marked and located, our technicians ran GPR to see potential unknown utilities or anomalies that could be threats during excavation work. The following utilities have been located and marked; gas, electric, communication, and water.

Standard report was put together to display the utilities on images taken in the field. Images are to be used as visual reference, they are not to scale and should not be used for measurements or anything else than their intended purpose. During preparation of report, the job site was reviewed. Special attention was taken to make sure no other utilities were missed as apart of our quality control procedure.
